HIGH TEMPERATURE ELECTRONICS TECHNOLOGY

PHASE II — FINAL REPORT

MAY 1984

AIRCRAFT ENGINE BUSINESS GROUP
ADVANCED TECHNOLOGY PROGRAMS DEPARTMENT
CINCINNATI, OHIO 45215

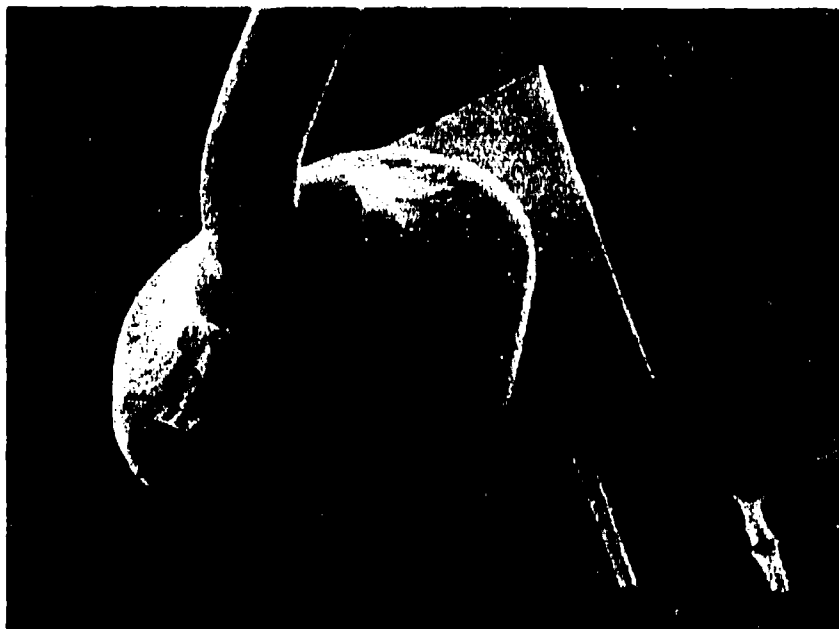
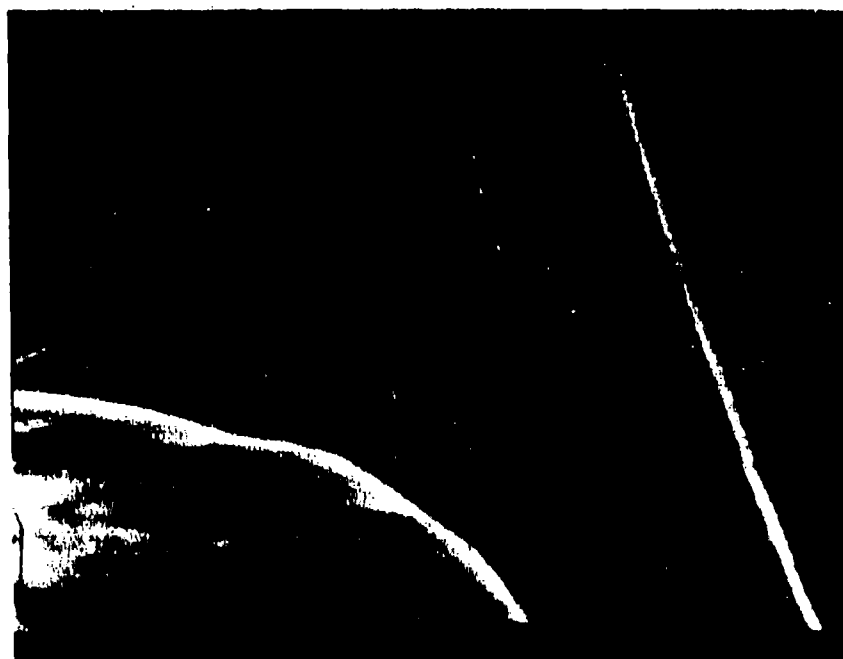
Figure 4-4. Metallization Lifting on a Bonding Pad
After 1220 Hours at 340° C.

Chip No. 6 was removed from Life Test "B" after 1220 hours at 340° C when all oscillators had ceased to function. A SEM analysis revealed a metallization adhesion problem as the probable cause of failure. Figure 4-4 shows how the metallization started to lift at the edges after 1220 hours at 340° C. Figure 4-5 shows how the narrow interconnect metallization at the interior of the chips lifted except for the via contacts to active silicon. Finally Figure 4-6 shows the metallization lifting around contact openings to the active silicon. The problem with poor metal adhesion was most severe with
